Why Indeed Did the WTC Buildings Completely Collapse?

By Dr. Steven E. Jones

ABSTRACT

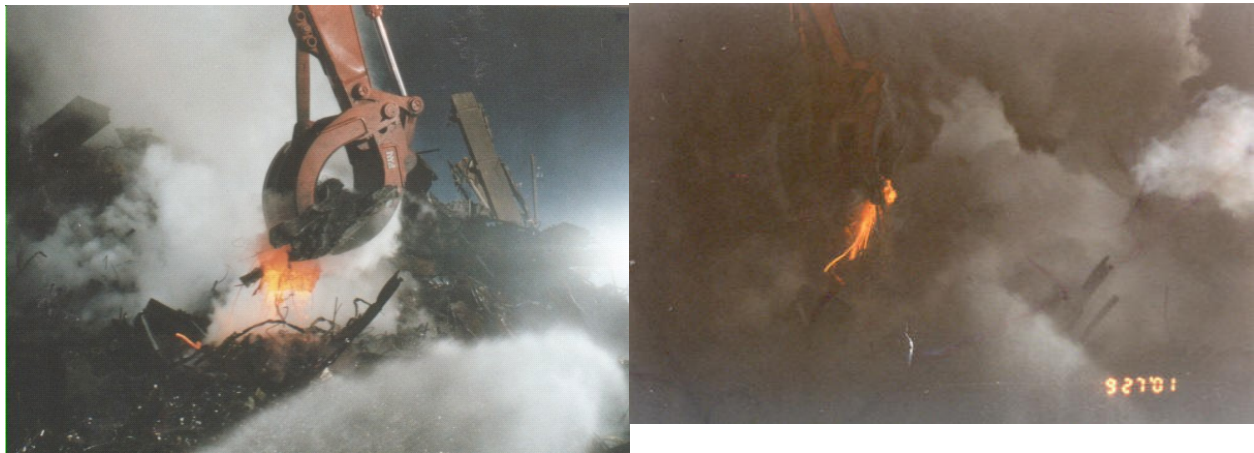
We start with the fact that large quantities of molten metal were observed in basement areas under rubble piles of all three buildings: the Twin Towers and WTC7. A video clip provides eye-witness evidence regarding this metal at ground zero: http://plaguepuppy.net/public_html/video%20archive/red_hot_ground_zero_low_quality.wmv. The photographs below by Frank Silecchia show chunks of the hot metal being removed from the North Tower rubble on September 27, 2001 (according to photographer's aid). Notice the color of the lower portion of the extracted metal -- this tells us much about the temperature of the metal and provides important clues regarding its composition, as we shall see.

Even without a direct elemental analysis, we can rule out some metals based on available data. The photograph in the introduction shows a chunk of hot metal being extracted at ground zero. The hottest portion of the chunk is the lower portion, which was deepest down in the slag, and the metal is seen to be yellow-hot, certainly above cherry-red hot. The following table (see <http://www.processassociates.com/process/heat/metcolor.htm>) provides data regarding the melting temperatures of lead, aluminum, structural steel and iron, along with approximate metal temperatures by color. Note that the approximate temperature of a hot metal is given by its color, quite independent of the composition of the metal. (A notable exception is falling liquid aluminum, which due to low emissivity and high reflectivity appears silvery-gray in daylight conditions, after falling through air 1-2 meters, regardless of the temperature at which the poured-out aluminum left the vessel. Aluminum does incandesce (glow) like other metals, but faintly, so that with the conditions described in the previous sentence (which prevailed at the WTC on 9/11), falling liquid aluminum will appear silvery-gray. Rapid oxidation of the hot flowing aluminum will contribute to the observed appearance. [Experiments: Jones, 2006])

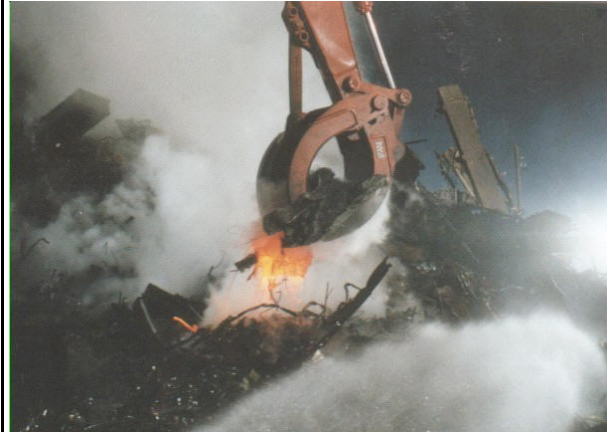
We see from the photograph above that solid metal from the WTC rubble existed at salmon-to-yellow-hot temperature (approx. 1550 - 1900 °F, 845 - 1040 °C.) The temperature is well above the melting temperatures of lead, zinc and aluminum, and these metals can evidently be ruled out since they would be runny liquids at much lower (cherry-red or below) temperatures. However, the observed hot specimen could be structural steel (from the building) or iron (from a thermite reaction) or a combination of the two. Additional photographs of the hot metal could provide further information and advance the research.

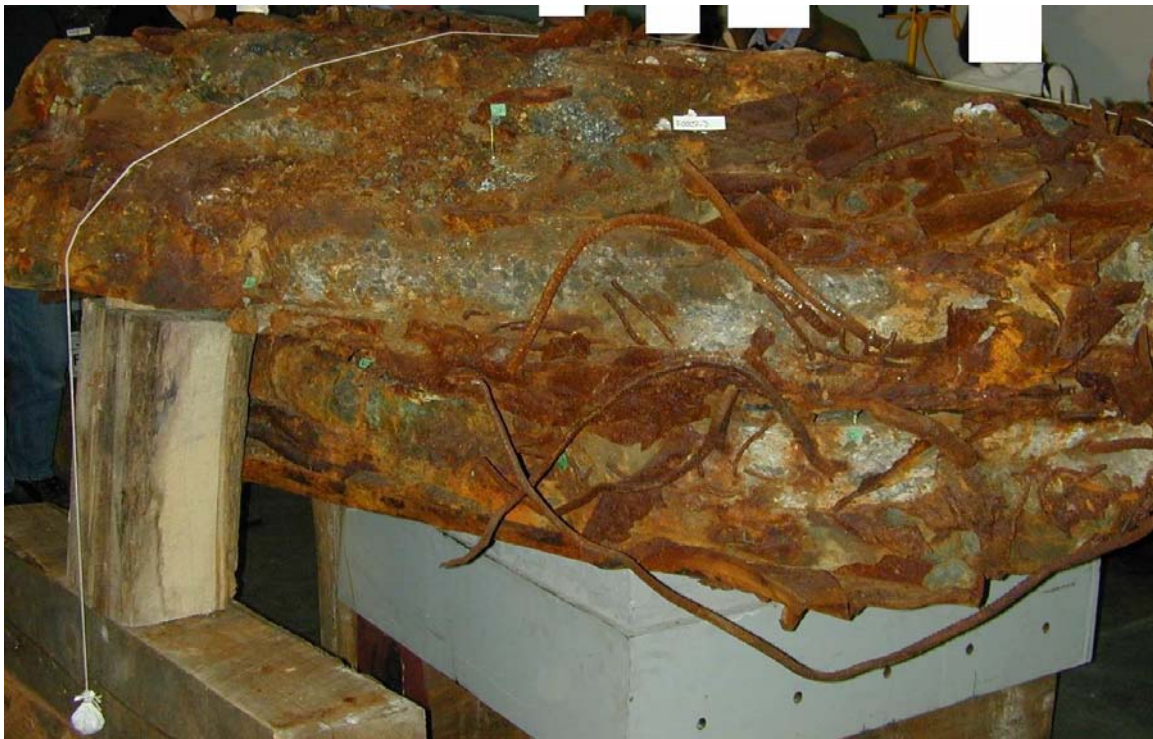
The following photograph has become available, evidently showing the now-solidified metal with entrained material, stored (as of November 2005) in a warehouse in New York:

The abundance of iron (as opposed to aluminum) in this material is indicated by the reddish rust observed. When a sample is obtained, a range of characterization techniques will quickly give us information we seek. X-ray energy dispersive spectrometry (XEDS) will yield the elemental composition, and electron energy-loss spectroscopy will tell us the elements found in very small amounts that were undetectable with XEDS. Electron-backscattered diffraction in the scanning electron microscope will give us phase information; the formation of certain precipitates can tell us a minimum temperature the melt must have reached. We will endeavor to obtain and publish these data, whatever they reveal.

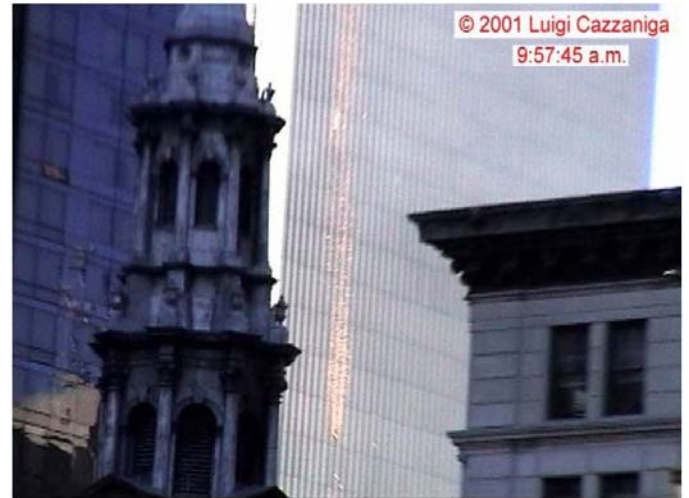
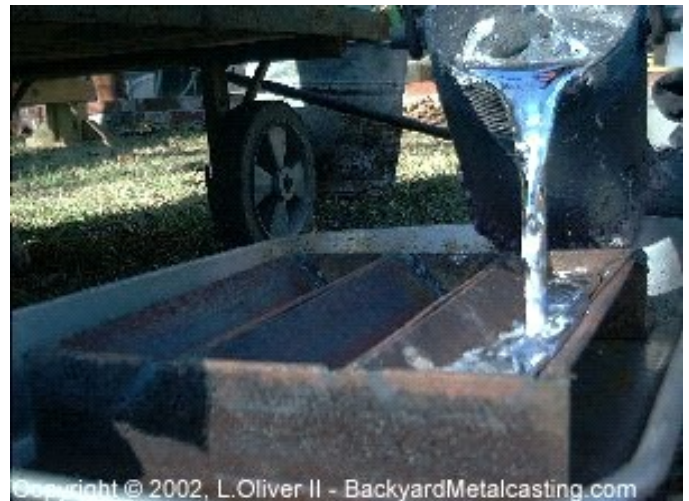
Is the falling molten metal from WTC Tower 2 (Top photos) more likely molten iron from a thermite reaction (lower left) OR pouring molten aluminum (lower right)?

Who can deny that liquid, molten metal existed at the WTC disaster? The yellow color implies a molten-metal temperature of approximately 1000 °C, evidently above that which the dark-smoke hydrocarbon fires in the Towers could produce. If aluminum (e.g., from the plane) had melted, it would melt and flow away from the heat source at its melting point of about 650 °C and thus would not reach the yellow color observed for this molten metal. Thus, molten aluminum is already ruled out with high probability. But molten iron with the characteristics seen in this video is in fact consistent with a thermite-reaction attacking the steel columns in the Tower, thus weakening the building just prior to its collapse, since thermite produces molten iron at yellow-to-white hot temperatures. (As some of the molten metal hits the side of the building in the video clip above, the white-hot interior is evidently exposed as the metal "splashes".) Also, the fact that the liquid metal retains an orange hue as it nears the ground (right photograph) further rules out aluminum, and suggests a mid-flight thermite reaction (typical of thermite).

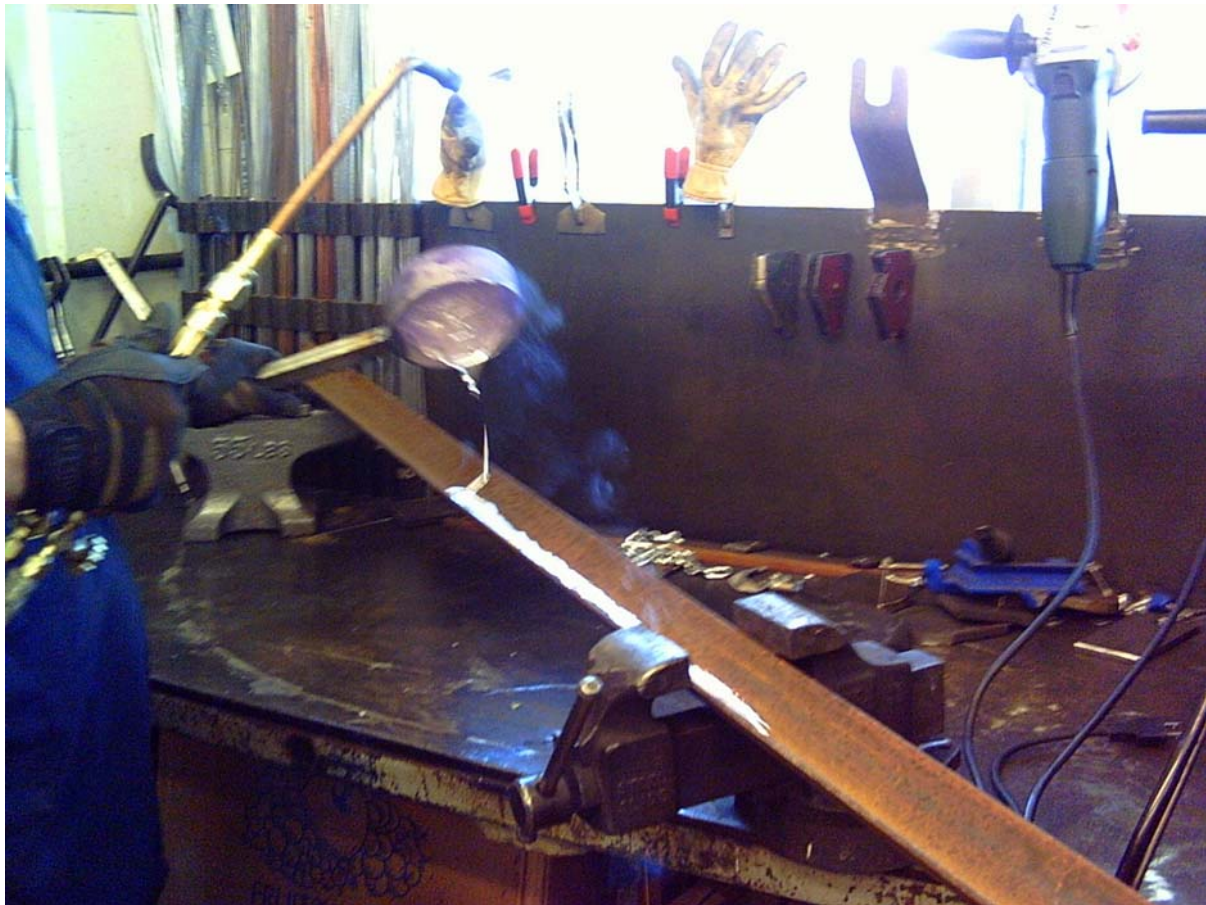
Molten aluminum poured onto rusted steel: silvery flow, and **no** violent reactions observed at all (contrary to predictions by some of a vigorous aluminum-rust “thermitic reaction”). Same result -- when the rusty steel piece was pre-heated with the torch.

We also noted that while a steel pan holding the aluminum glowed red and then yellow hot, when poured out the falling aluminum displayed a silvery-gray color, adding significantly to the evidence that the yellow-white molten metal flowing out from the South Tower shortly before its collapse was NOT molten aluminum. (Recall also that the yellow color of the molten metal (video clip above) implies a temperature of approximately 1100°C -- too high for the dark-smoke hydrocarbon fires burning in the building.) This is a point worth emphasizing: aluminum has low emissivity and high reflectivity, so that in daylight conditions after falling through air 1-2 meters, molten aluminum will appear silvery-gray, while molten iron (with its characteristic high emissivity) will appear yellow-white (at ~1100°C) as observed in the molten metal dripping from the South Tower just before its collapse (see: <http://www.supportthetruth.com/jones.php>). We also recall that this molten metal, after falling approximately 150 meters (or yards) still retained a reddish orange color (photograph above). This is not the behavior of falling, molten aluminum.

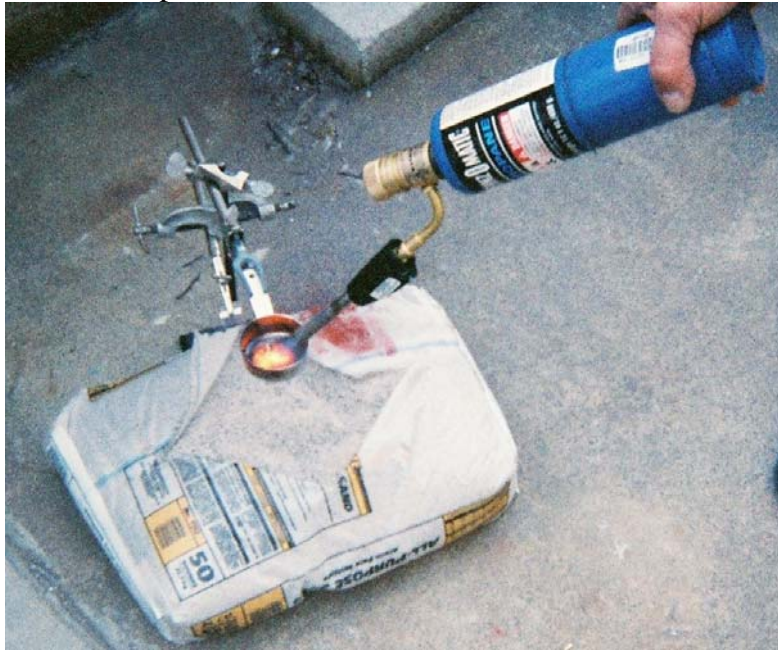
Thermite did not ignite when heated with a propane torch.

It is important to note that initiating the thermite reaction requires temperatures well above those achieved by burning jet fuel or office materials -- which is an advantage of using thermite charges over conventional monomolecular explosives such as TNT, RDX and PETN. Below is a photograph of an experiment performed by the author and colleagues at BYU in which a sample of thermite was heated to orange-hot temperature (about 1700 °F). We demonstrated that the thermite reaction would not ignite at this high temperature. Later, the

thermite reaction was triggered by burning a magnesium strip in contact with the thermite. An electrical superthermite "match" could have been used and remotely triggered via radio signal.

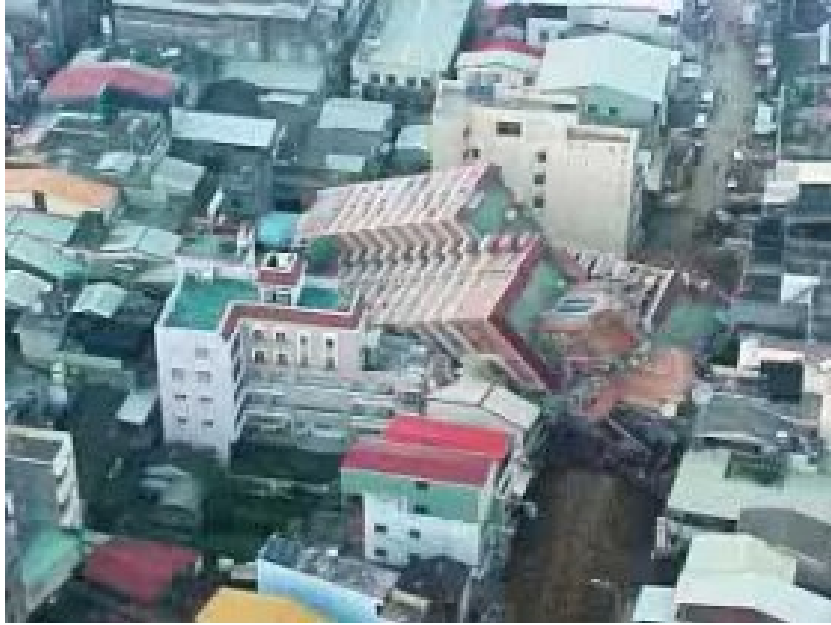
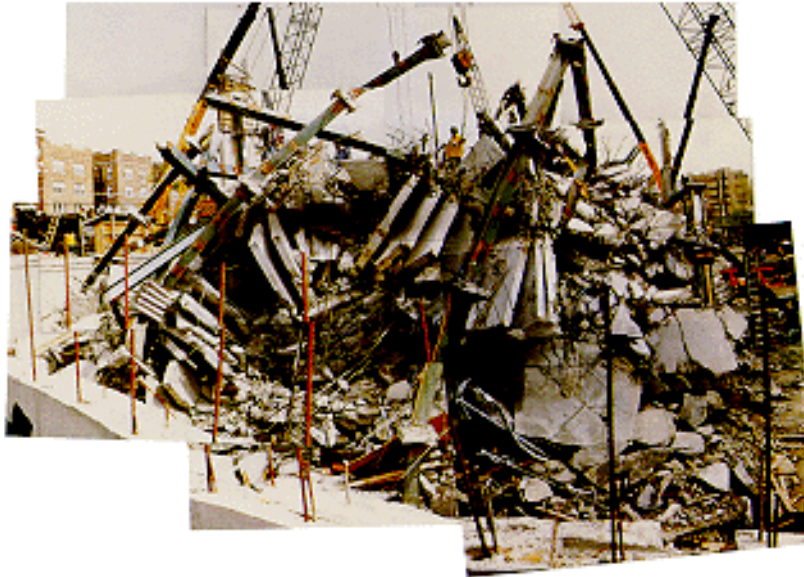
Non-symmetrical collapse of tall buildings when due to random causes. L'Ambiance Plaza collapse (right) shows how pancaked concrete floor slabs are largely intact and clearly reveal stacking effects with minimal fine dust, as expected from random progressive collapse. By contrast, concrete floors in the Twin Towers and WTC 7 were pulverized to dust -- as is common in controlled demolitions using explosives.

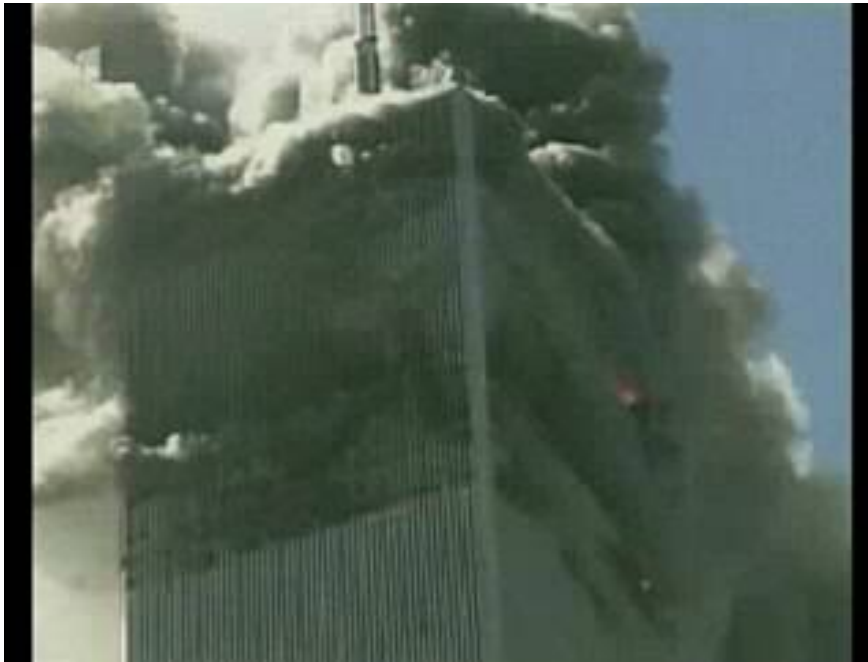
North Tower showing antenna (top) at beginning of collapse.

Review of videotape recordings of the collapse taken from various angles indicates that the transmission tower on top of the structure began to move downward and laterally slightly before movement was evident at the exterior wall. This suggests that **collapse began with one or more failures in the central core area of the building.** (FEMA, 2002, chapter 2; emphasis added.)

Yes, we can see for ourselves that the antenna drops first from videos of the North Tower collapse. (See http://911research.wtc7.net/wtc/evidence/videos/wtc1_close_frames.html; also <http://home.comcast.net/~skydrifter/collapse.htm>.) A NY Times article also notes this behavior:

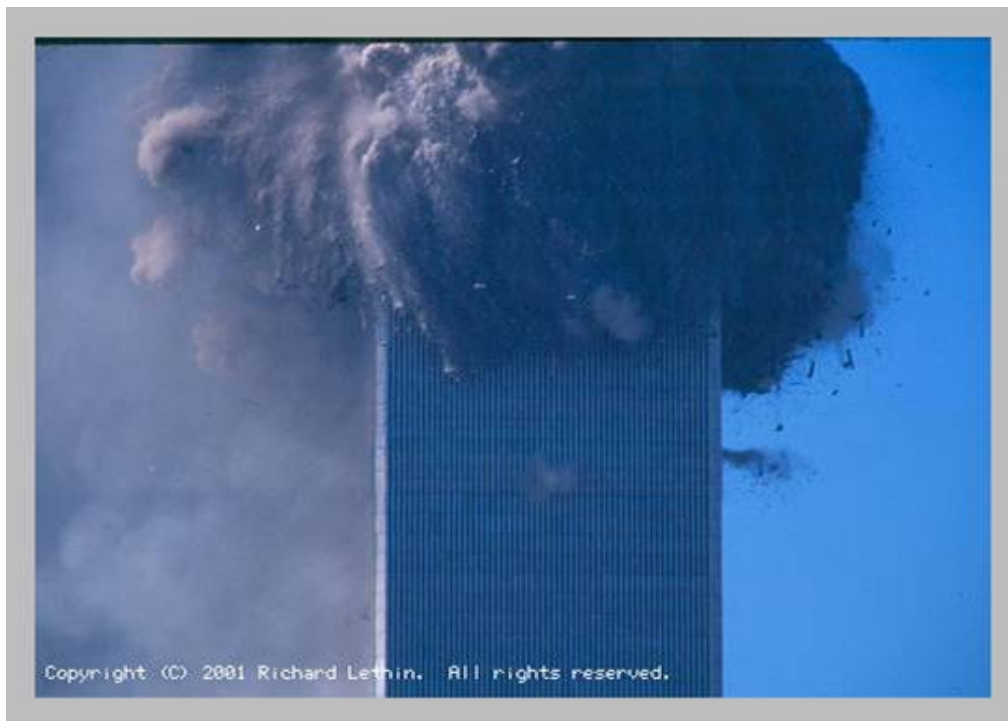
North Tower during top-down collapse.
Notice mysterious horizontal plumes far below pulverization region.

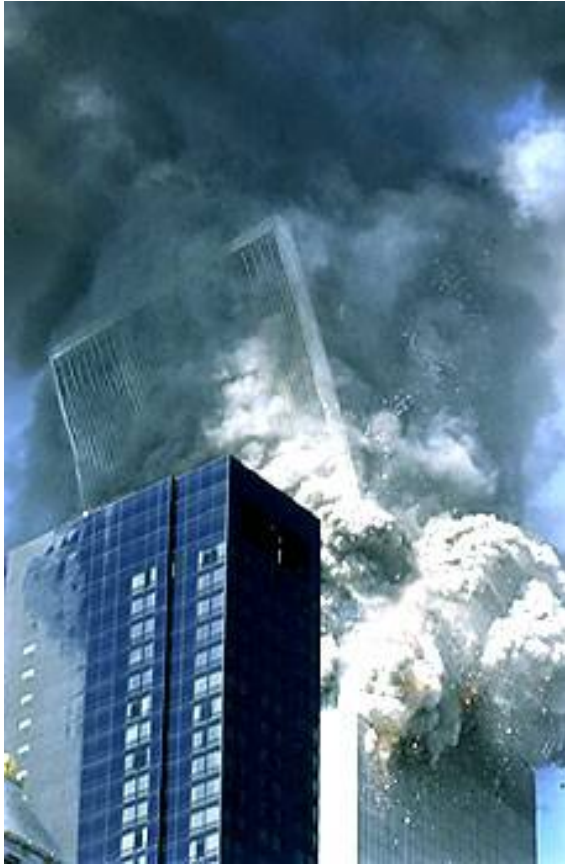
Top ~ 30 floors of South Tower topple over.
What happens to the block and its angular momentum?

We observe that approximately 30 upper floors begin to rotate as a block, to the south and east. They begin to topple over, not fall straight down. The torque due to gravity on this block is enormous, as is its angular momentum. But then – and this I’m still puzzling over – this block turned mostly to powder *in mid-air*! How can we understand this strange behavior, without explosives? Remarkable, amazing – and demanding scrutiny since the US government-funded reports failed to analyze this phenomenon. But, of course, the Final NIST 9-11 report “**does not actually include the structural behavior of the tower after the conditions for collapse initiation were reached.**” (NIST, 2005, p. 80, fn. 12; emphasis added.)

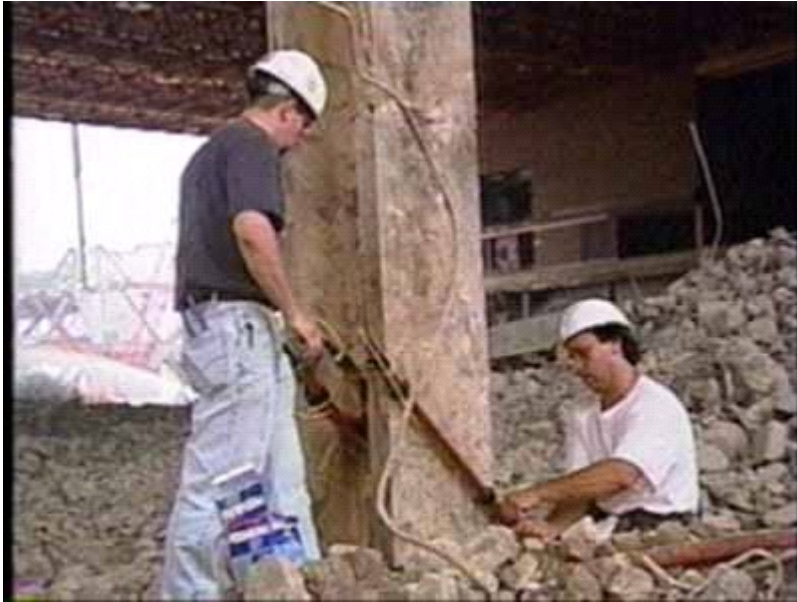
Above: two men install a conventional cutter charge to steel column, preparing for a controlled demolition of the building. Notice the narrow width/size of the explosive cutter charge. From History Channel: “Wrecking ball – Modern marvels” and thanks to Robert Moore and <http://piratenews.org/911con.html> . For comparison, observe one of the angle-cut columns seen at Ground Zero after 9/11/2001, below. (Notice especially the uneven cut at the back of the column and the clinging previously-molten metal on both the outside AND the inside of the column, suggesting this was NOT cut using an oxy-acetylene torch, but rather that a highly exothermic chemical reaction was involved in cutting through this steel column.)

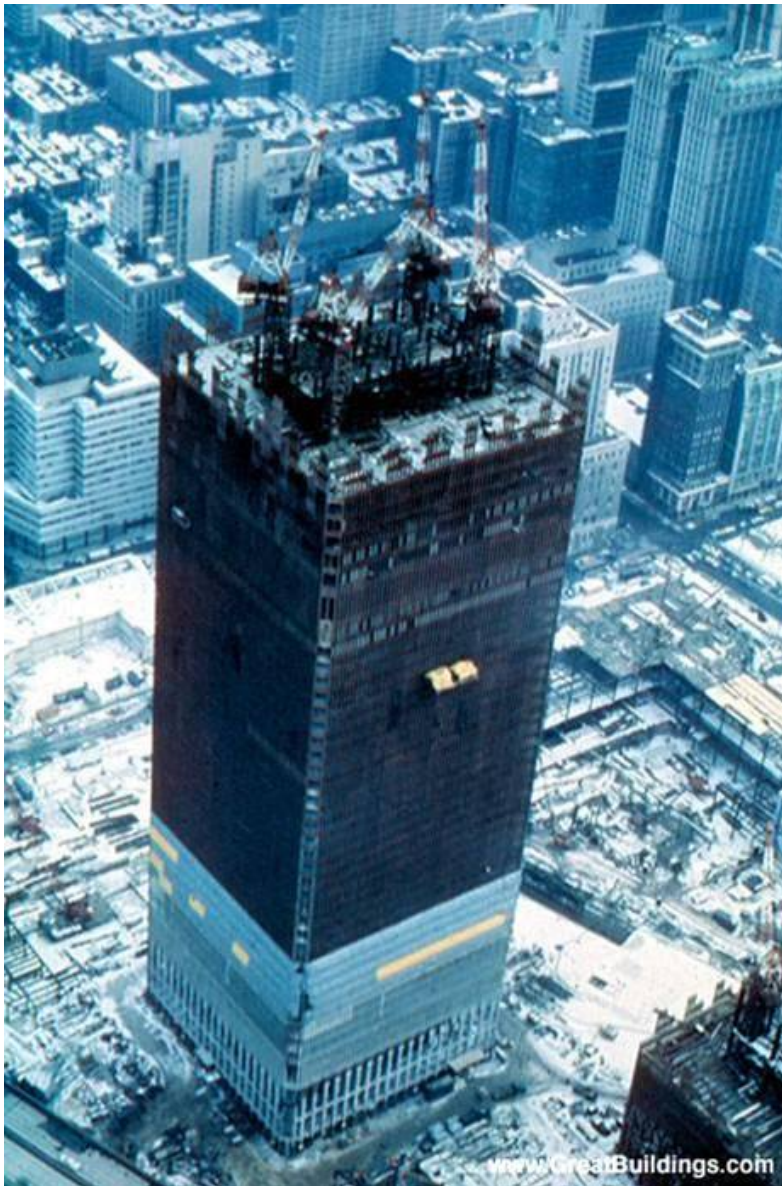
The WTC towers were solidly constructed with 47 steel core columns and 240 perimeter steel columns. 287 steel-columns total.

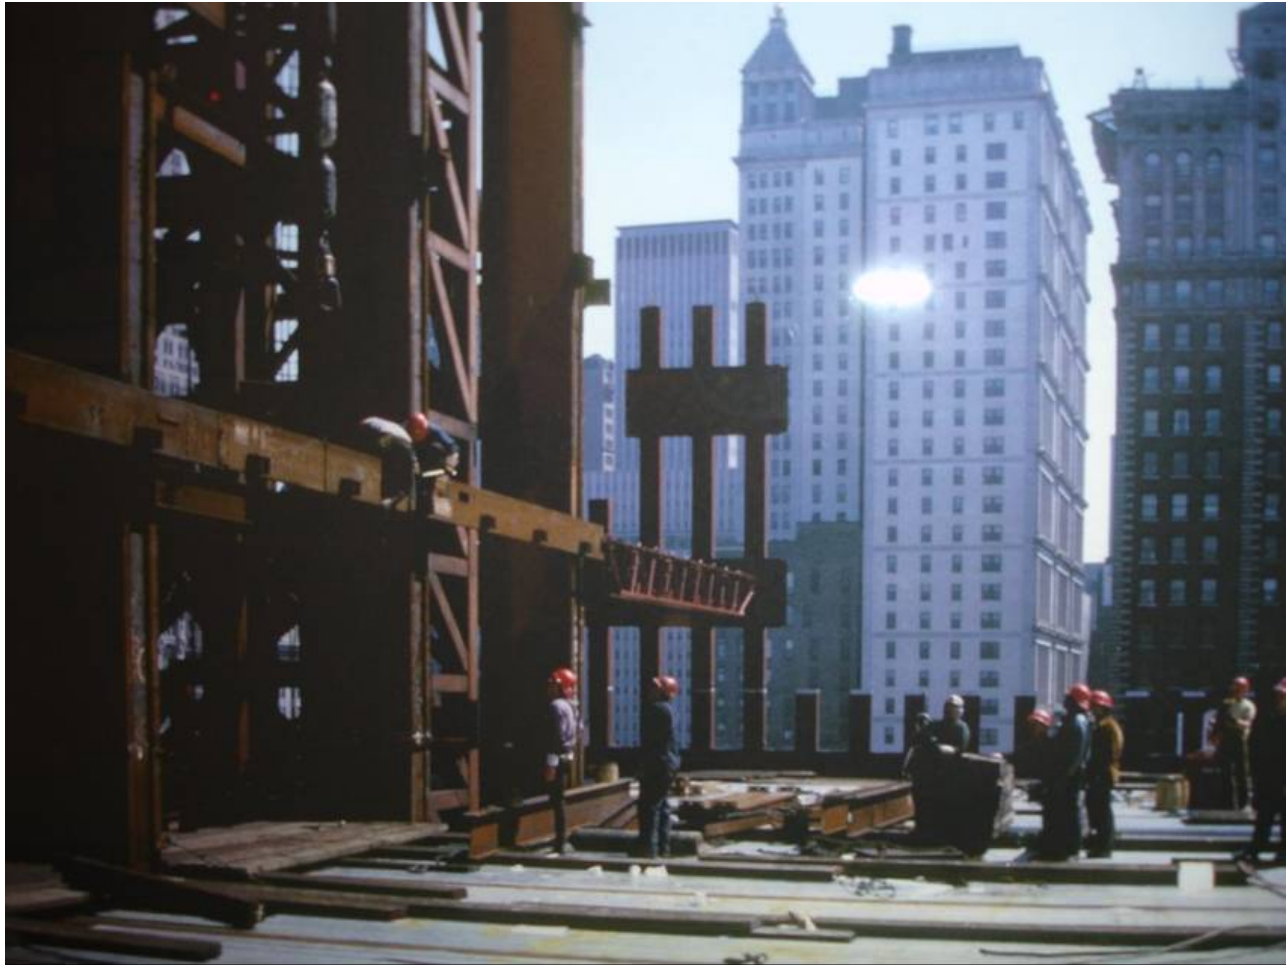
Steel-frame: Huge core (left) is an enormous heat sink. Notice workers standing on floor pan which is firmly attached to the interconnected core columns. Clearly, **the Towers were not “hollow tubes.”**
